**HISTORIC AND ARCHITECTURE RESEARCH  
OF DESIGN TERRITORY  
TBILISI  
MIRZA SHAFI STREET**

Classified plan design

## PROJECT TERRITORY DESIGN

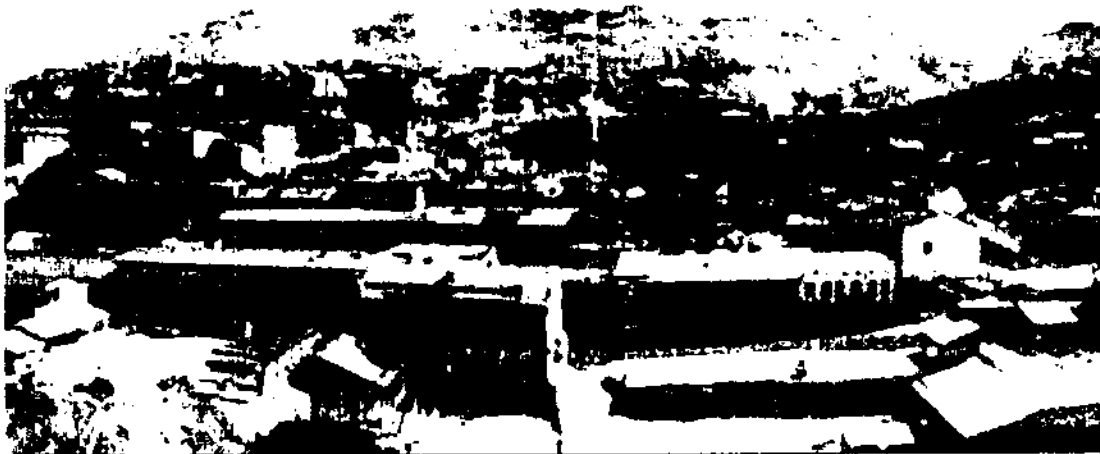
**PHOTO OF 20s OF THE XX CENTURY**

On the above photo of 1920s, filed in the archive, we see entire development of Seydabad and upper perimeter of Mirza Shafi Street. Photo image is vague and houses are not visible in details, though size of most of them and their shape is visible. For that period one stage of district development was completed.

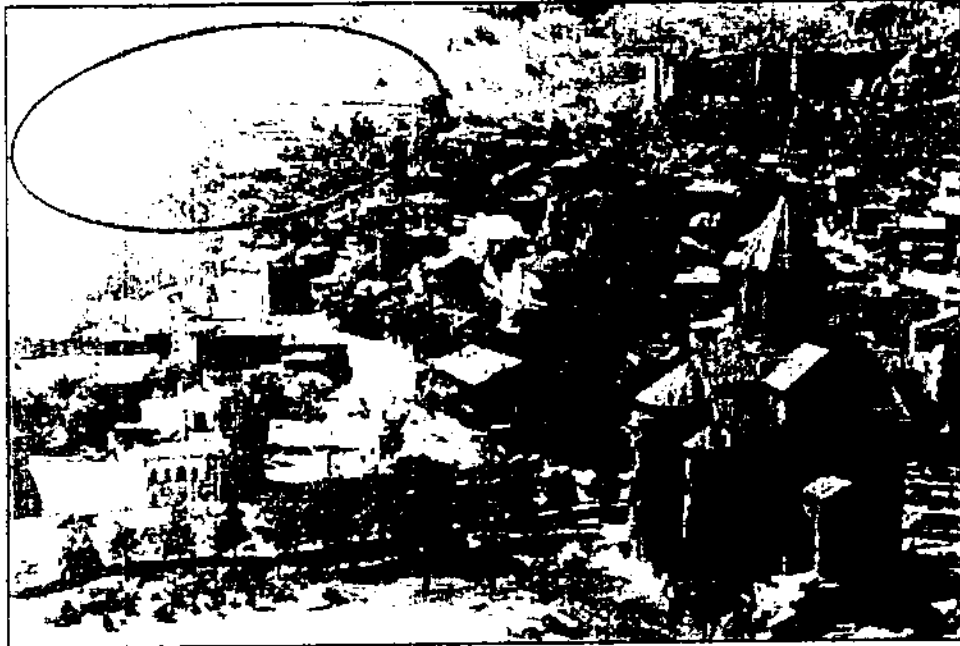
ABANOTUBANI, MIRZA SHAFI STREET, 1940s

First important structural change in this district in the middle years of the XX century started by “removing” of small urban structures and creation of wide areas. Over Riv. Tsavkistskali was made roofing along Abano Street. At the same time they were transforming existed houses considering new social requirements, as the houses before being private property, actually were distributed as communal houses and population started to make changes and additions of structures to the houses by their own consideration and this caused changes to appearance of street development and houses lost their original face. This process continued till the end of the century and it is being in process till present. On the photo there is visible development of Abano Street and upper section of Mirza Shafi Street.

On the photo we as well see some small area on the lower perimeter of Mirza Shafi Street, in the ravine. For that time new left embankment is not yet developed.

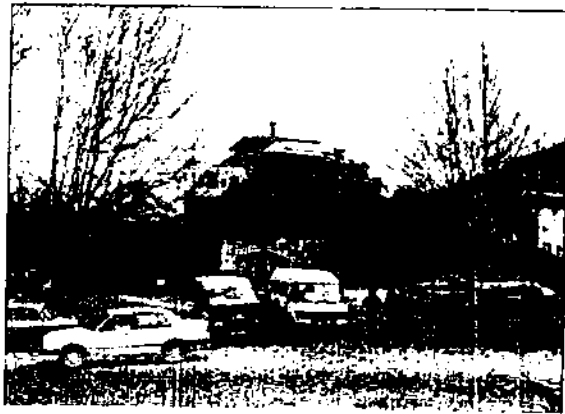
**LARGE HOTEL**

No total changes took place in Abanotubani development. Though large hotel in Abanotubani square and institute building in Botanic Garden, which was not in compliance with the situation, resulted in dissonance in existed development.

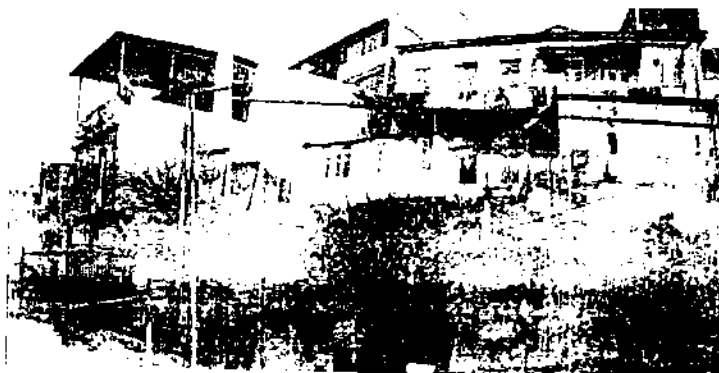
**LOW QUALITY ADDITIONAL STRUCTURS**

In parallel, architecture appearance of residential houses are distorted by further additionally built structures, that mainly are built by population at own consideration, without any design and architectural concept.

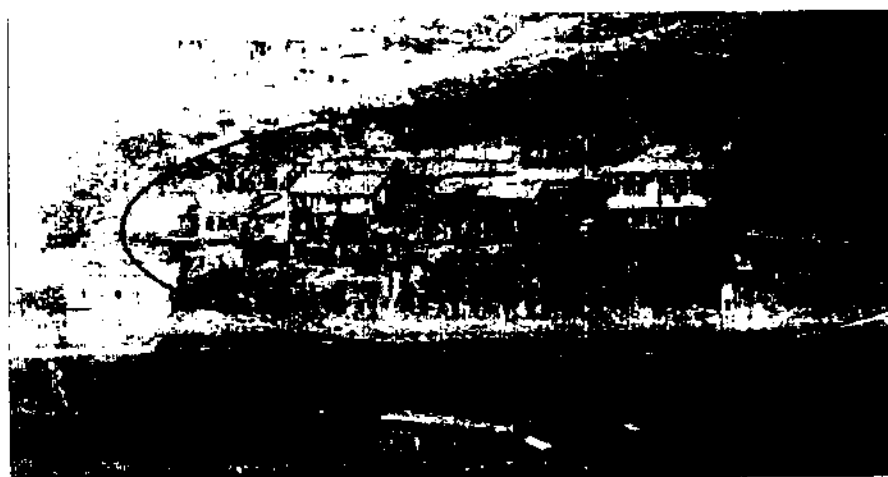
#### IV SECTION, PHOTO OF THE END OF THE XIX CENTURY

**IV section – from house № 16 till the end; houses №16-48**

These buildings are visible from far vision points and form prospective scale. It is interesting with structure, street stairs, and method of allocation of the relief. Most of the houses is of a low architectural value (there is distinguished only the house №46). Architectural appearance of each house is not as much valuable as the general structure of development and so it is possible to remove existed constructions and design new areas and structures, considering general features of the district.

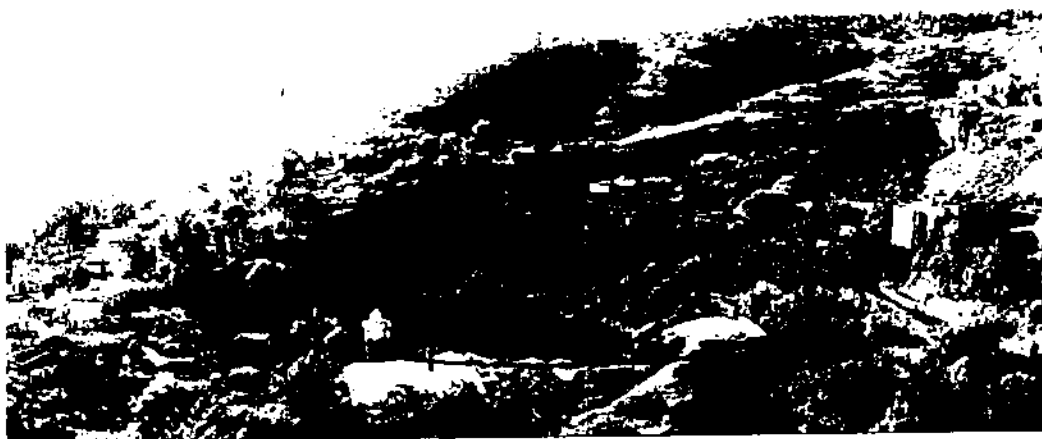
**V SECTION, PHOTO OF THE END OF XIX CENTURY**

**V section – ravine along the whole lining of the lower perimeter of the street**

Ravine is presently uninhabited. Here were quite small areas. Presently there is maintained trace of several ruins.

This section is included in the landscape protection zone. It is desirable to arrange here recreation zone, with planted walking paths and park type leisure facilities.

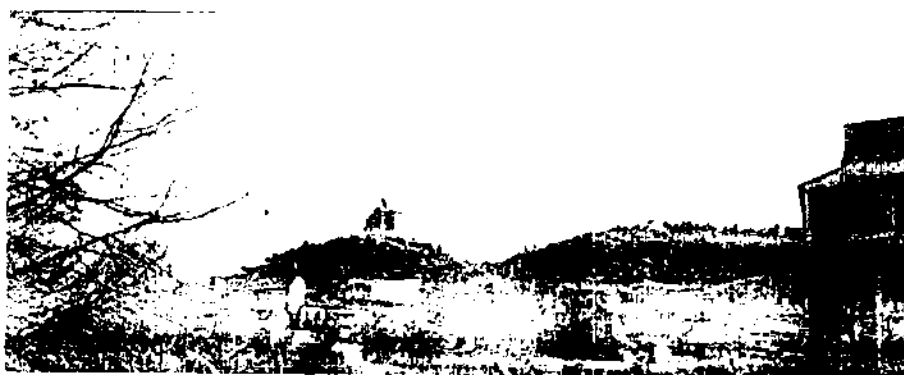
LOWER PART OF MIRZA SHAFI STREET, 2007

Development of the slope is of a terrace type and the appearance of each house is not as much valuable as the general structure of development.

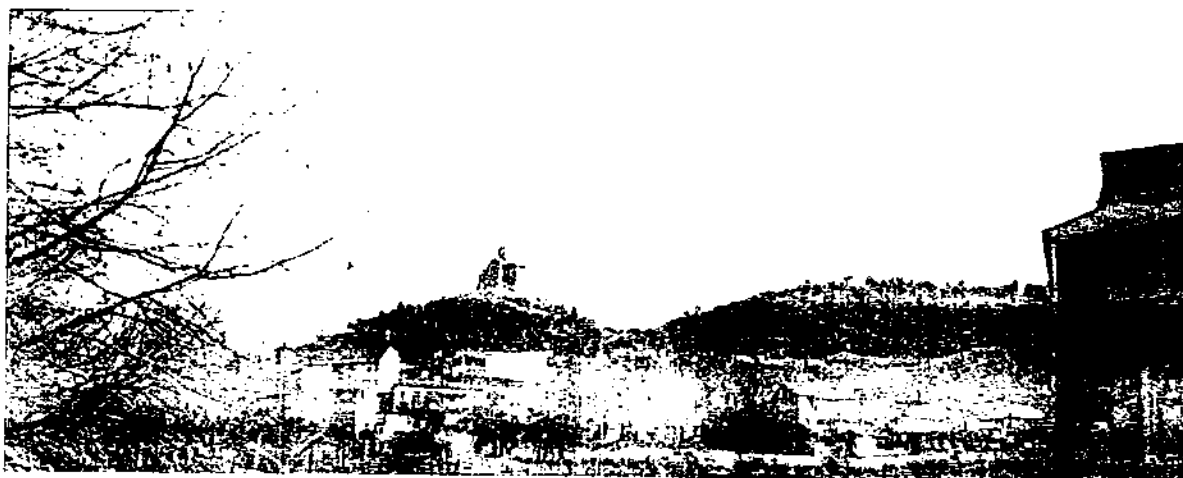
MIDDLE PART OF MIRZA SHAFI STREET, 2007

Leading components of area vision is system of sloping roofs and terrace type planning, façade of each building is less valuable and some sections of development are degraded by later changes and half collapsed small and ugly areas.

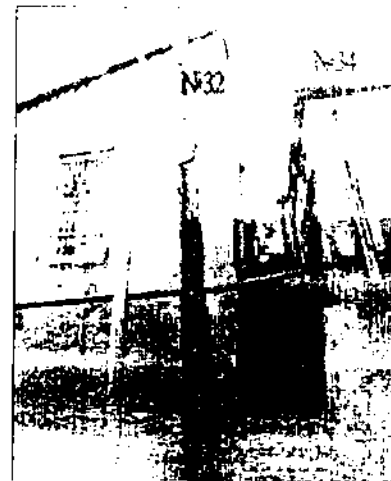
MIRZA SHAFI STREET, SECTIONS OF STREET STAIRS, 2007

Mobile systems of street-stairs, featured for the district, are aligned between houses. These narrow street-stairs are very convenient and the shortest way to reach several buildings at the same time and as well are designed for the areas erected in the deepness. This is the condition of a live rhythm of the development.

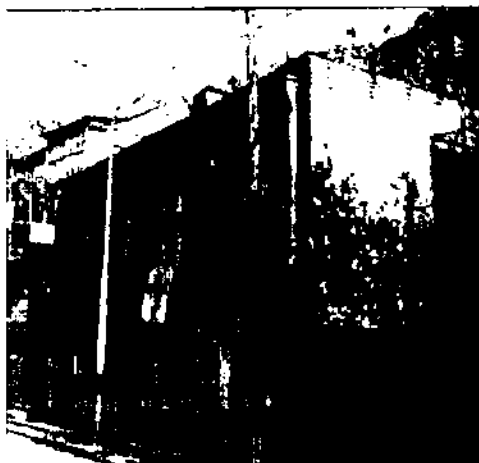
Residential house, Mirza Shafi Street N20

9. General assessment of physical condition of the building

To replace this house, it is possible to construct new building, considering artistic and architectural features of the district

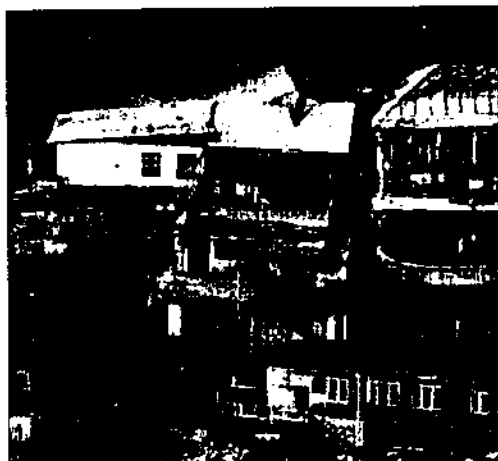
Residential house, Mirza Shafi Street N24

#### 9. General assessment of physical condition of the building

*To replace this house with design of new building, it might be interesting with its structure – with open terraces transited from the street to the slope in a step type, which will be indivisible part of live rhythm of development. As well existed mobile system of street staircases featured for the district will be used.*

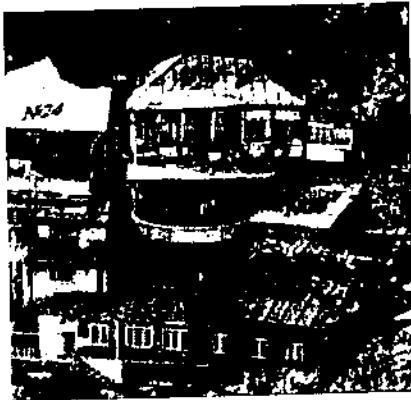
Residential house, Mirza Shafi Street N26

#### 9. General assessment of physical condition of the building

To replace this house with design of new building, it might be interesting with its structure – connection of street staircase with a large area transited from the street to the slope, is a very useful and shortest way to access several buildings in parallel. This on its side results in live rhythm of development.

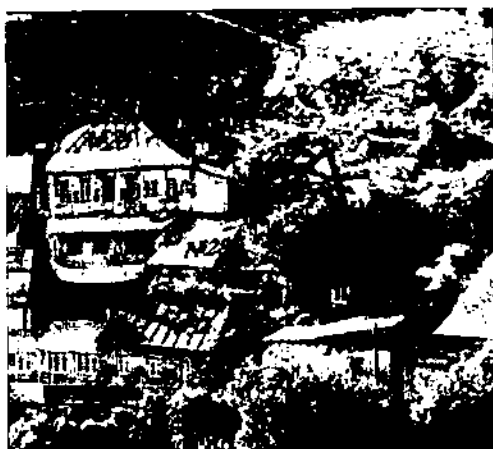
Residential house, Mirza Shafi Street N28

In total, the house has no independent high artistic value. It is important somehow from its structure – with its location in the deepness, relief location and useful location in dense urban tissue, which conditions general diversity of development.

## 9. General assessment of physical condition of the building

*In case of design of a new house, to replace the existed one, new structure is possible to design*

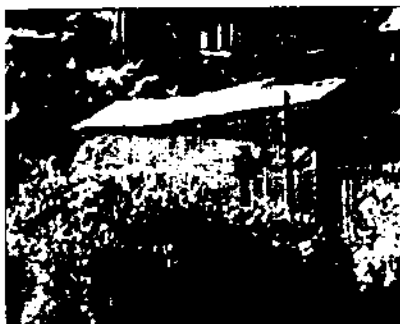
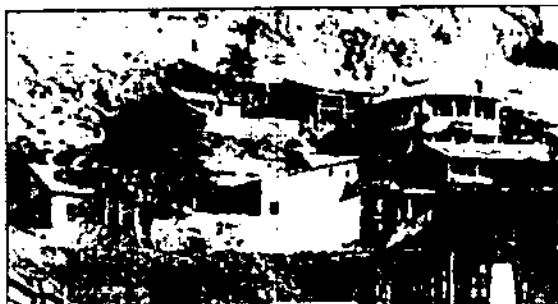
Residential house, Mirza Shafi Street N32, two story house

## 9. General assessment of physical condition of the building

To replace these constructions, new areas may be built, considering general structure

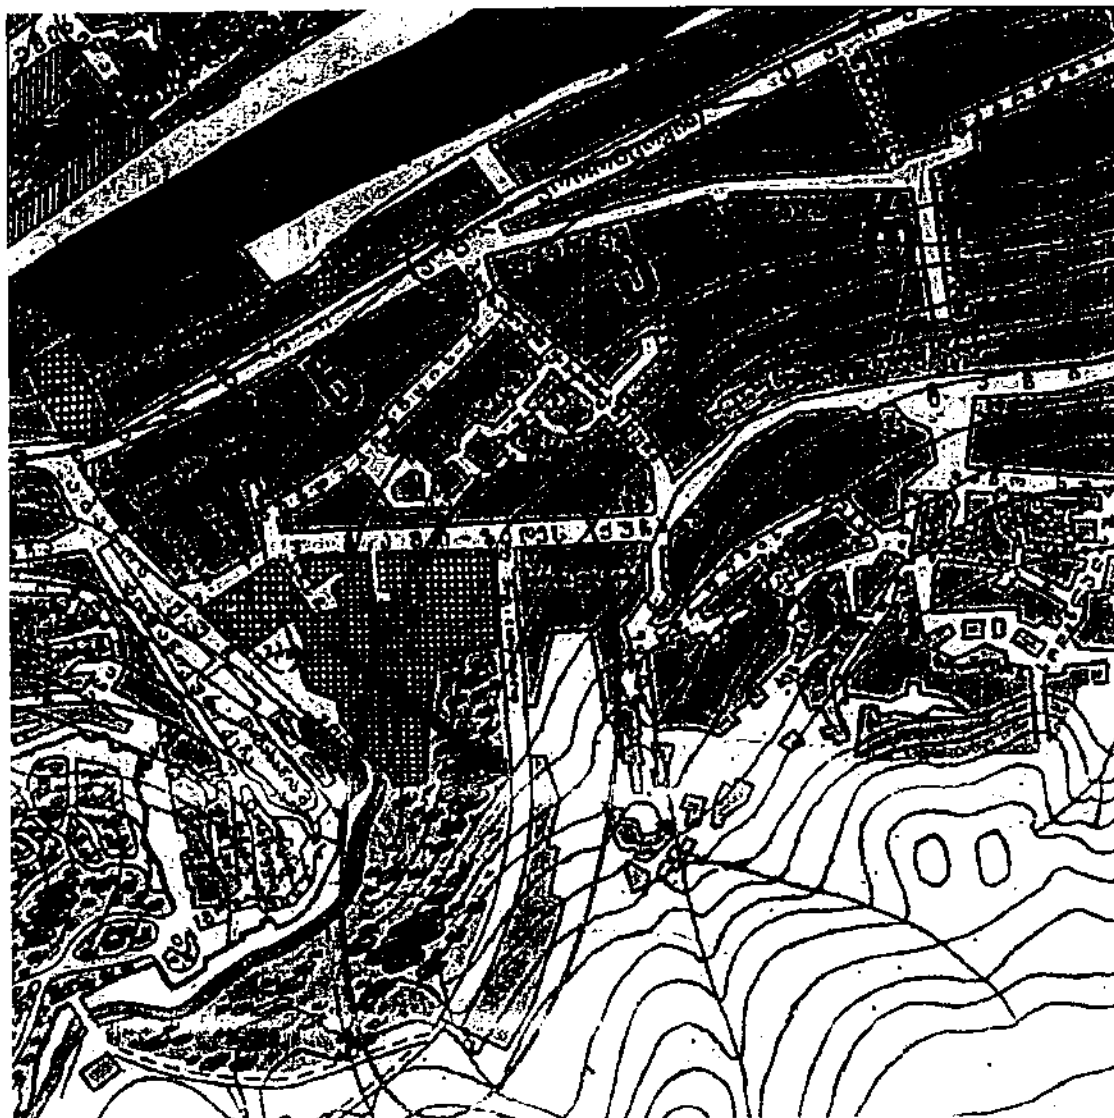
**TBILISI PLAN 1924**  
**VI – DISTRICT**  
**Kharfukhi**

**RESEARCH TERRITORY**

**SHUSHA STREET – GERZEL BAAZOV STREET**  
**TATAR TURN – MIRZA SHAFI STREET**  
**TAGI-ZADE STREET – GRISHASHVILI STREET**
